SAFETY ORDER

No: SO-P4 091002 1

DOPPELMAYR CTEC SAFETY ALERT BULLETIN SA-08-021 WOLFURT KD08003E

Title: Tower Failure Due to Water Intrusion

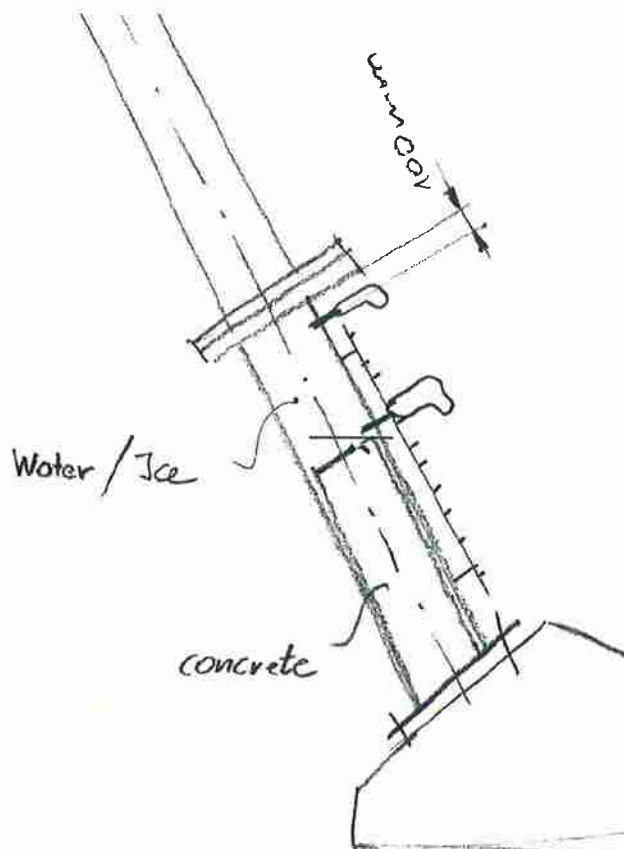
For tower shaft sections partially filled with concrete through the top plate, check the tower section with the hammer method as described previously. If water/ice is suspected, drill a small hole 3/8" - 1/2" (10 - 12 mm) approx. 2 inches (50 mm) below the top plate on the uphill side of the tower (behind the ladder). Tower shafts with a cover for concrete fill on the outside of the shaft already have a drain hole and the cover can be removed for inspection purposes. **If ice is found in this section, this shall be cause for immediate and continued closure of the lift to public transportation** and must be reported to the nearest Doppelmayr representation office for review and recommended repair procedures.

A small drain hole 3/8" - 1/2" (10 - 12 mm) is required to eliminate the water above the concrete level. See illustration below.

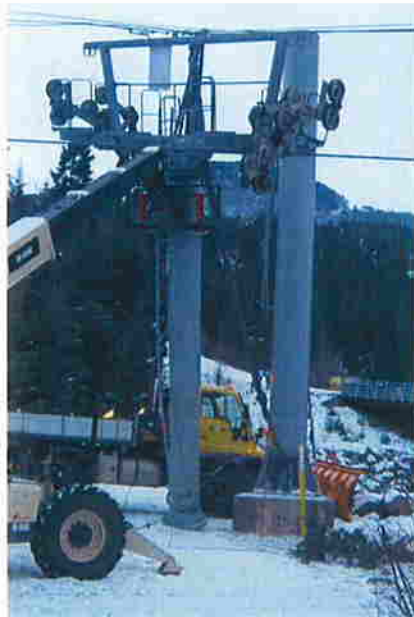
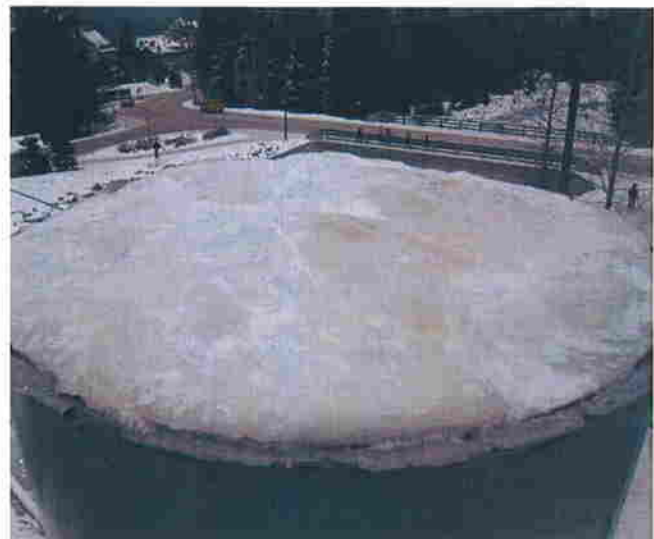
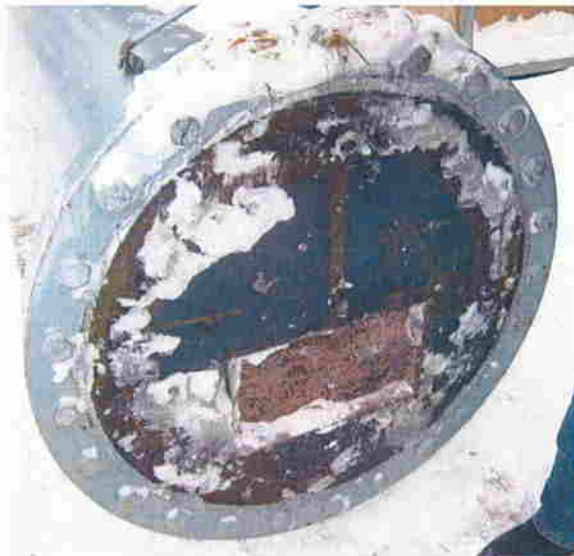
Tower with 2 x 6T/2FR assemblies;
16,7m tall; 9,7m of 30" tube spliced
to 7m of 24" tube.

Lower tower section filled approx.
5m with concrete, the remainder
with ice.

Temperature approx. -12°C/10°F.

Bottom tower section top flange
plate was pushed off the shaft by
ice and caused top tower section to
separate and fall.

The comm. line and the haul ropes
supported the tower head so the
upper section came to rest in a
more or less vertical position on the
ground.
